## **IMPORTANT SAFETY NOTICE**

To: **All Users of Sperian Warrior Self-Contained Breathing Apparatus (SCBA)**

The purpose of this Important Safety Notice is to advise you of a potential safety issue with the Rapid Intervention Crew/Company Universal Air Connection (RIC UAC, hereafter referred to as the UAC) used in Sperian Warrior SCBAs.

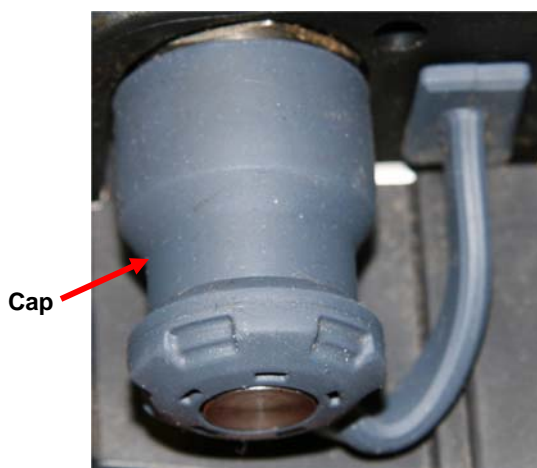
Figure 1

Under some conditions, it is possible to pull the protective dust cap off the pin in the pin-and-cap assembly, resulting in the pin remaining stuck in the UAC coupling. If the cap has separated from the assembly, the pin stuck in the coupling would prevent the coupling from functioning in a rapid intervention scenario.

This condition can occur when the pin has not been removed from the coupling for a long time. There is an internal o-ring in the coupling that seals against the pin. If the pin has not been “exercised” by removing it from the coupling periodically, it can take a set (become stuck) against the o-ring. The amount of force necessary to then remove the pin-and-cap assembly from the coupling may exceed the ability of the cap to remain attached to the pin, and the cap may separate from the pin.

1. Attempt to remove the pin-and-cap assembly from the UAC coupling (see Figures 1 and 2).

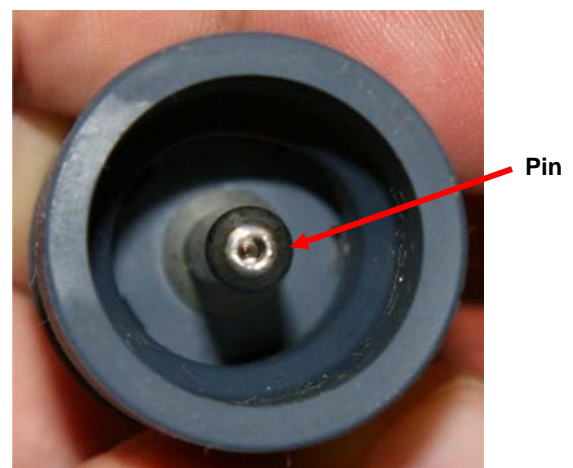
Figure 2

This condition can also occur if the pin has been bent during use.

2. If the pin-and-cap assembly can be removed from the UAC coupling, inspect the pin to ensure that it is not bent (see Figure 2). If it is bent, contact your local Sperian Warranty Service Center to have a Sperian-certified technician replace the pin-and-cap assembly (Sperian part number 975641) on the Warrior; then follow the lubricating procedure in Step 3 below.
3. If the pin is not bent, use a cotton swab to apply a **thin** coat of Molykote 33 Light (Sperian part number 820489) to the sides of the pin shaft from just below the tip of the pin to approximately ¼-inch below the tip of the pin. Do not overlubricate. Do not apply Molykote 33 Light to the tip of the pin. Ensure that the cotton swab does not deposit any lint on the pin shaft. You do not need to be a Sperian-certified technician to apply Molykote 33 Light to the UAC pin.
