IMPORTANT SAFETY NOTICE UPDATE

To: **All Users of Sperian Warrior Self-Contained Breathing Apparatus (SCBA)**

The purpose of this Important Safety Notice is to advise you of a potential safety issue with the Rapid Intervention Crew/Company Universal Air Connection (RIC UAC, hereafter referred to as the UAC) used in Sperian Warrior SCBAs.

Notice Number 1-071111

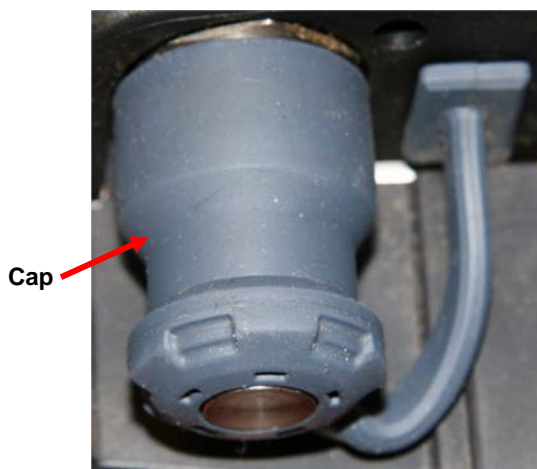
Figure 1

Under some conditions, it is possible to pull the protective dust cap off the pin in the pin-and-cap assembly, resulting in the pin remaining stuck in the UAC coupling. If the cap has separated from the assembly, the pin stuck in the coupling would prevent the coupling from functioning in a rapid intervention scenario.

This condition can occur when the pin has not been removed from the coupling for a long time. There is an internal o-ring in the coupling that seals against the pin. If the pin has not been "exercised" by removing it from the coupling periodically, it can take a set (become stuck) against the o-ring. The amount of force necessary to then remove the pin-and-cap assembly from the coupling may exceed the ability of the cap to remain attached to the pin, and the cap may separate from the pin.

1. Attempt to remove the pin-and-cap assembly from the UAC coupling (see Figures 1 and 2).

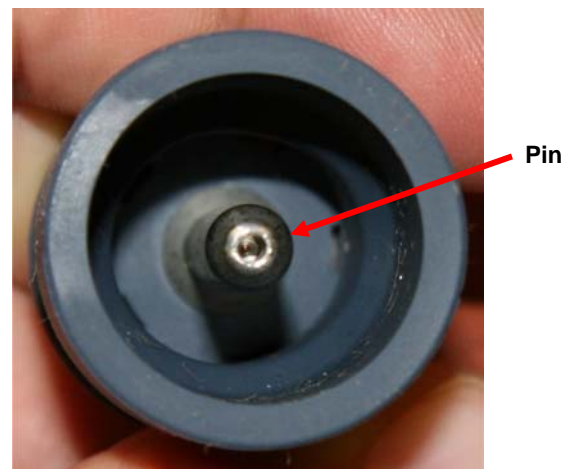
Figure 2

This condition can also occur if the pin has been bent during use.

2. If the pin-and-cap assembly can be removed from the UAC coupling, inspect the pin to ensure that it is not bent (see Figure 2). If it is bent, replace the pin-and-cap assembly (part number 963500) on the Warrior (see the information regarding the new pin-and-cap assembly in the last two paragraphs on this page); then follow the lubricating procedure in Step 3 below.
3. If the pin is not bent, use a cotton swab to apply a **thin** coat of Molykote 33 Light (Sperian part number 820489) to the sides of the pin shaft from just below the tip of the pin to approximately ¼-inch below the tip of the pin. Do not overlubricate. Do not apply Molykote 33 Light to the tip of the pin. Ensure that the cotton swab does not deposit any lint on the pin shaft. You do not need to be a Sperian-certified technician to apply Molykote 33 Light to the UAC pin.
