IMPORTANT INFORMATION NOTICE

To: All Users of Sperian TwentyTwenty® Plus CBRN SCBA Facepieces, 2720 Series

The purpose of this Information Notice is to advise you of an issue with the Sperian TwentyTwenty Plus SCBA facepiece, part number 272036 (large, black, medium nose cup, Kevlar headnet). Only this configuration is affected.

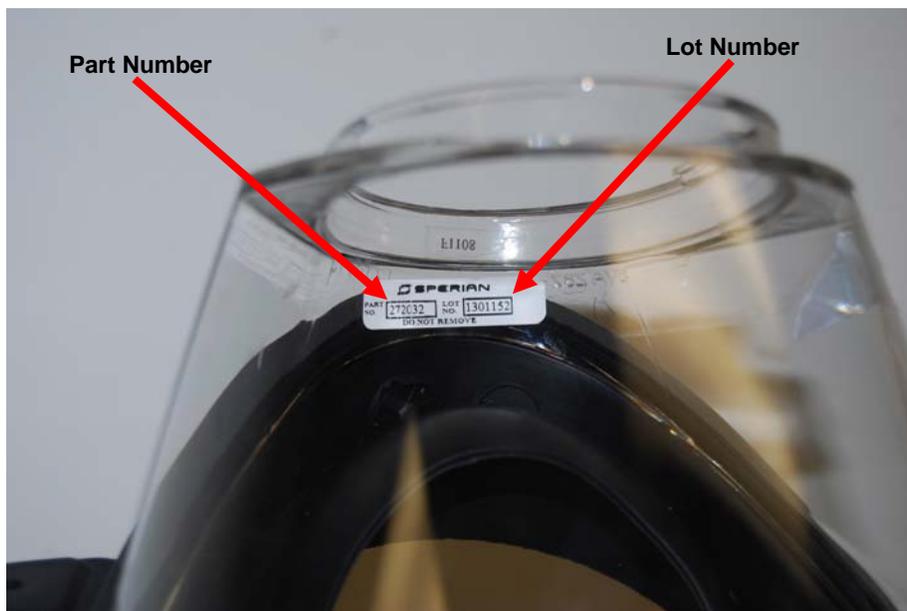
The lot number (in this case, 1301152) and part number for the facepiece can be located on the label on the inside of the facepiece in question, as shown in Figure 1 below. Please note that the part number listed on the label will be **272032**, not 272036, because the part number changes once the headnet is installed, and the lot number label is attached prior to headnet installation.

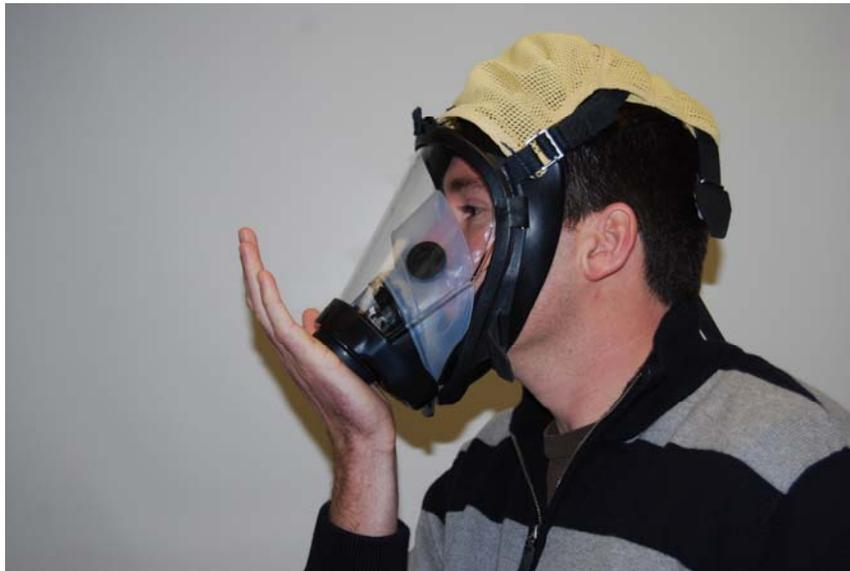
1. Place the palm of your hand over the Air Klic as shown in Figure 2 below.

2. Inhale and hold your breath for a few seconds. The facepiece should collapse on your face without leaking.
3. If the facepiece leaks, reposition, check the straps, and repeat the fit check.

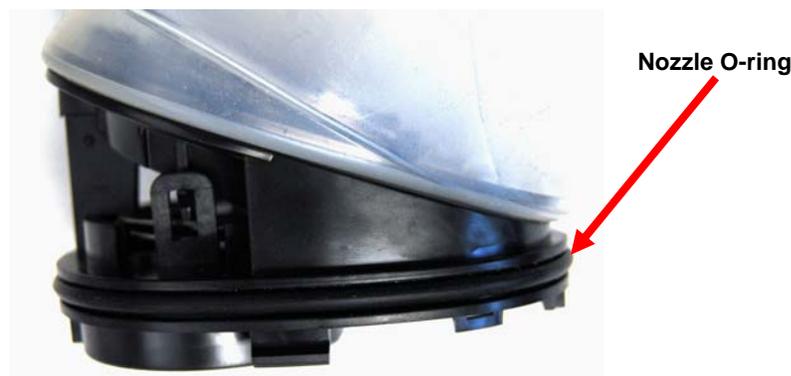
Figure 3

This problem is isolated to lot number 1301152. We have discovered that one facepiece manufactured under that lot number had the nozzle o-ring installed incorrectly. If a facepiece is assembled with an incorrectly installed nozzle o-ring, an outward leak can develop, which could reduce the duration of the SCBA. There were 65 facepieces manufactured in this lot. While we believe that the incorrectly installed o-ring was a unique case, we do not have test records to verify that the other 64 facepieces were built correctly.

1. As shown in Figure 3, make sure that the nozzle assembly o-ring is seated correctly.

2. Reassemble the facepiece per the Sperian Warrior Operation Manual or the Sperian Warrior Service Manual.
3. Perform a facepiece fit check.
